MSC APOLLO 13 INVESTIGATION TE. W. FINAL REPORT

RELATED SYSTEMS EVALUATION

VOLUME I SUMMARY

MAY 1970

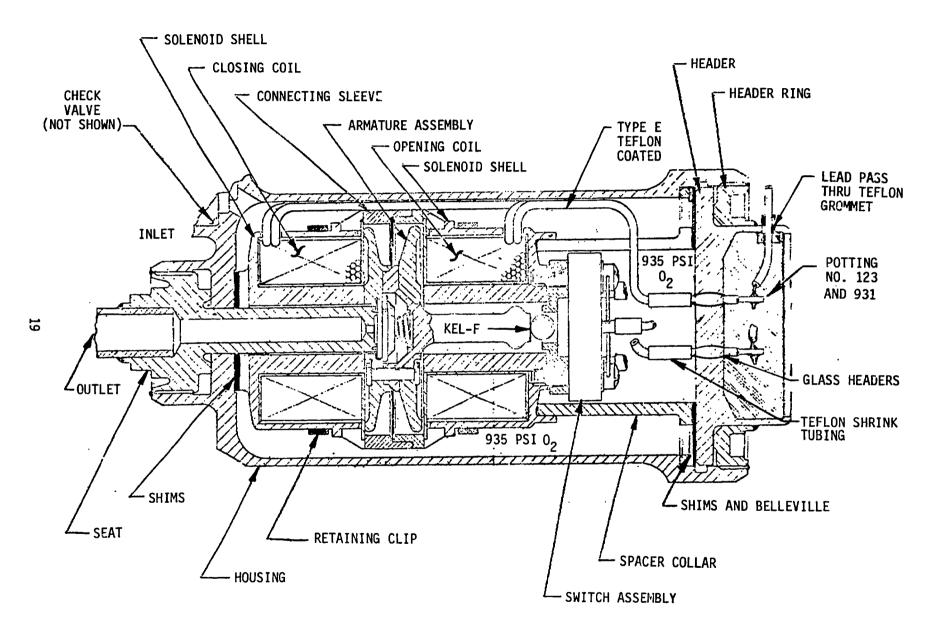
FIGURE A-1.- FUEL CELL VALVE MODULE SOLENOID VALVE.

The direct contact between high pressure gaseous oxygen (935 psi) and Teflon-covered power wiring which cannot be inspected after final assembly, such as in the fuel cell oxygen shut off solenoid, is considered an unacceptable design.

Complete the redesign of the fuel cell oxygen shutoff valve (or system) already initiated.

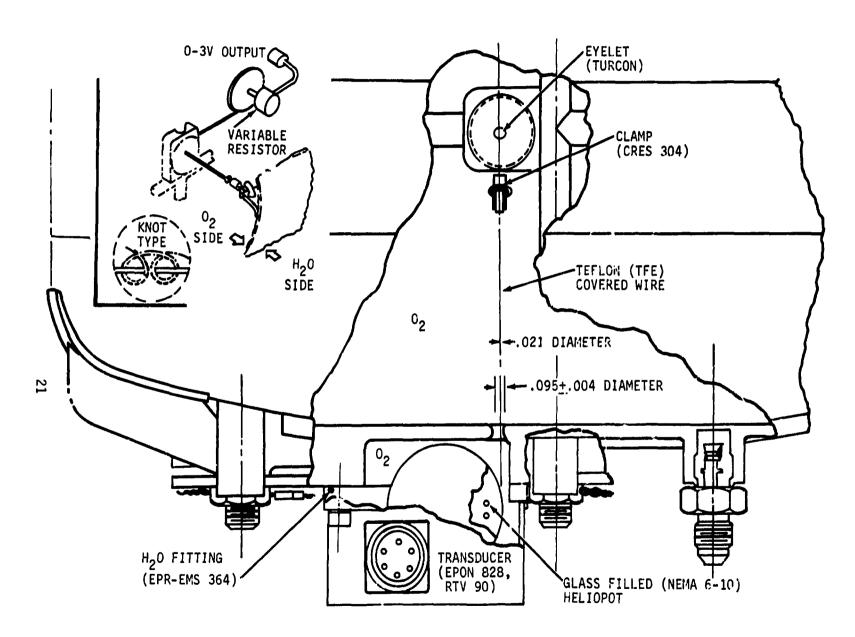
FIGURE A-3.- CM POTABLE AND WASTE WATER QUANTITY TRANSDUCER.

The quantity gaging system (including the electronics) in the potable water and waste water tanks is exposed to oxygen at pressures of 25 psia during flight and 35 psia during countdown. The electronics is supplied by 28 Vdc through two 5 amp circuit breakers. The acceptability of this design will require additional ignition tests which have already been initiated.

Perform analyses of the water quantity gaging system to determine the integrity of the transducer cover and the non-propagation of flame to the bladder for a worst case short in the transducer. If the results indicate a marginal factor of safety, perform a test using actual hardware for both flight and ground conditions. At the same time, the requirement for a water quantity gaging system should be re-examined to determine if it is mandatory for flight.

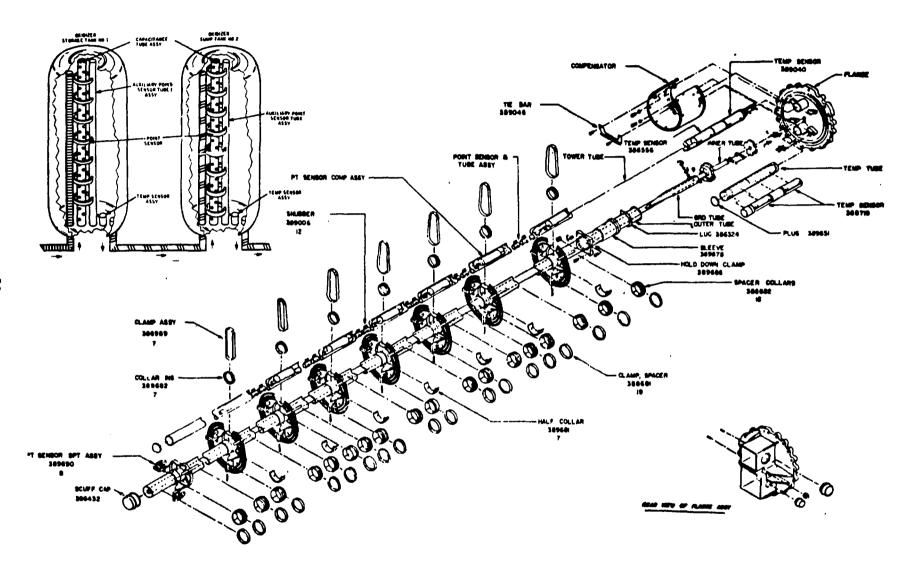
FIGURE A-5. - OXIDIZER PROBE ASSEMBLY.

It was not possible to establish the acceptability or unacceptability of the direct contact of electrical components and Teflon with oxidizer and fuel which exists in the SPS quantity gaging sensors. Analysis indicates there should be no problem. Test have been initiated to confirm this analysis.

Complete the testing already initiated to determine whether sustained reactions can be initiated in the SPS quantity gaging sensors within the energy limits of each application.

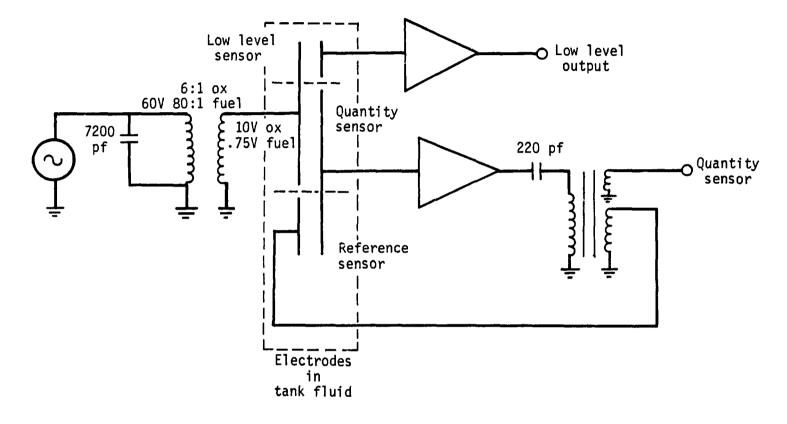
FIGURE A-8.- PQGS SENSOR SCHEMATIC.

- a. None of the electrical components investigated constitute ignition sources in their normal operating modes. Only the PQGS normally exposes electrical devices directly to the pressurized fluid. After thorough analysis it is concluded that adequate circuit protection is provided to preclude ignition.
